## Stucco Art of Nalanda Excavated Site, District Nalanda, Bihar: An Archaeological Overview

Sachin Kr. Tiwary

Assistant Professor, Department of Ancient Indian History Culture and Archaeology, Faculty of Arts, Banaras Hindu University, Uttar Pradesh

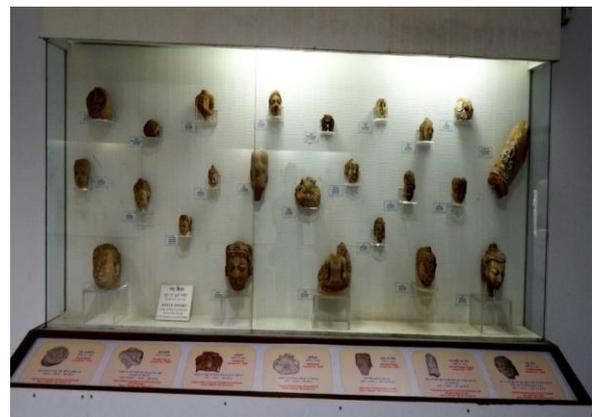
**Figure3.** The stucco made Kirtimukha and other panels displayed in Nalanda Site Museum, Nalanda, Bihar

The excavation of this site has exposed eleven major monasteries and six temples in additions to a number of minor shrines, votive stupas and other structure. The excavations carried out by the Archaeological Survey of India continuously from the years 1915 to 1983 (**Chauley, 2002:35**) have brought to light innumerable stucco images detached (**Fig.3**) and attached on both form

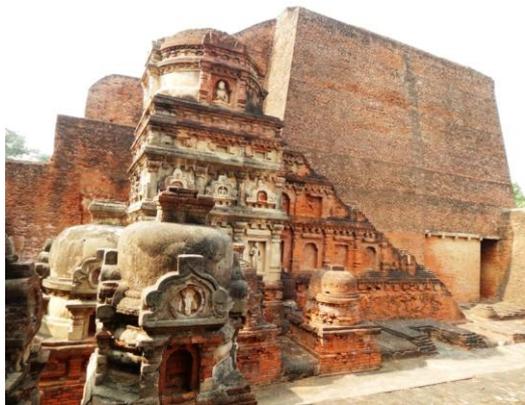
**Figure 6.** General view of the temple no. 03, Nalanda archaeological site, Nalanda, Bihar

At temple no. 3 (**Fig.6**) the earliest stuccos are assigned to c. 5<sup>th</sup> cen. A.D. but they are actually buried deep in the same temple. The stuccos that

Most of the stuccos of Nalanda found within the niches surrounding the outer surface of the temple no. 3 are badly damaged but a few of them are surviving. The theme is purely Buddhist figure like: *Buddha*, *Bodhisattva*, *Jataka* stories and life scene of Buddha. The faces of the male figures are along and sometimes round and the lower lips, prominent noses and with prominent feminine characteristics. Wear round earrings and a toque. Others ornament like, armllets, bangles, griddle, necklaces are visible. The figures are representing either standing in the attention, *Abhanga*, seated in *Padmasana* or *Lalitasana*. The figures of the Buddha are also found in seated and standing pose. Sometimes he is represented in the *Bhadrasana* pose. Unlike the drapery of the

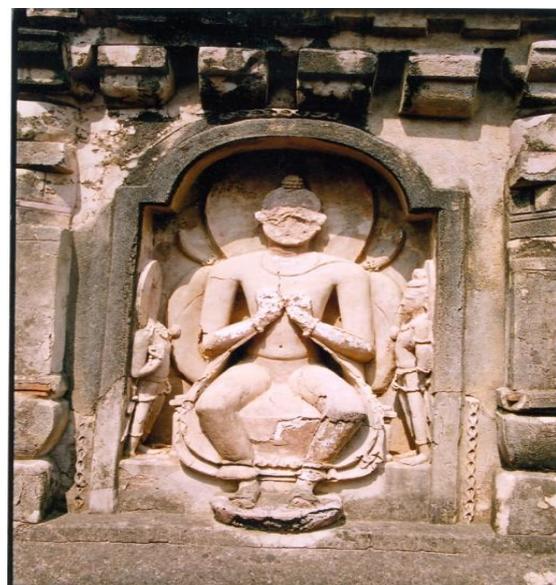
**Figure 8.** Image of Lord Buddha in preaching posture, Nalanda archaeological site, Nalanda, Bihar (Above)

- Buddha seated on a high throne in *Bhadrasana* or *Pralambapadasana*, extending the *Dharmachakra mudra* (Fig.8).
- Scene of Rajgir miracle (Fig.9).
- Buddha seated on throne in *Dharmachakra mudra*.
- Buddha stands in the middle on his right leg, placing his leg in *sukhasana mudra*.
- *Dipankara* Buddha stands in *sukhasana mudra* (Fig.10).
- Buddha extends *varada mudra*.
- Buddha is seated cross-legged in *padmasana*.
- The *Nidanakatha* jataka story in which the Buddha is seen a three-hooded Cobra male figure with folded hands *anjali mudra* in *sampadaasthanaka mudra*.
- Buddha in *bhumisparsa mudra*.
- Buddha in *Samadhi mudra*,
- Buddha figure is seated on a high throne in *bhadrasana* or *pralambapadasana* and expounding the first sermon with *dharmachakra mudra*.
- Buddha seated cross-legged on an inverted lotus.

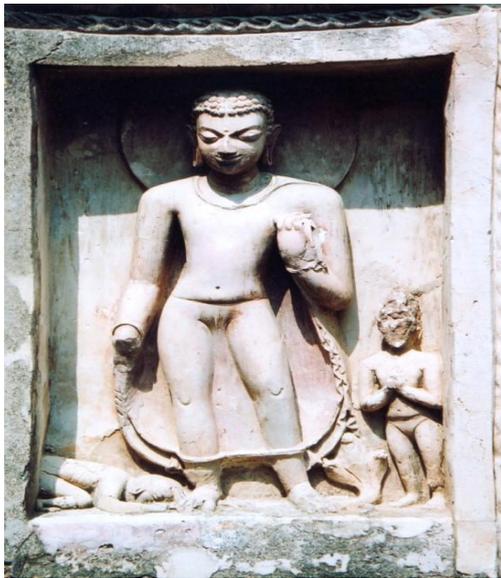
**Figure 9.** Scene of a miracle related to Rajgir-NalHasthi-Daman, Nalanda archaeological site, Nalanda, Bihar (Below right with an elephant icon)

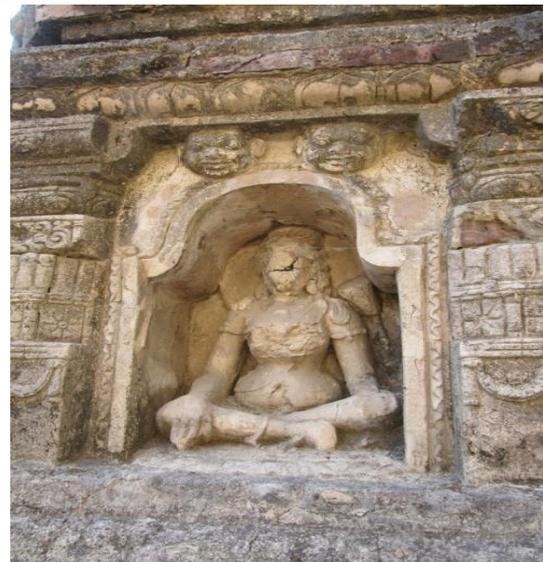
**Figure 11.** Image of goddess *Tara*, Nalanda archaeological site, Nalanda, Bihar

- Two-armed *Tara* (**Fig.11**) seated at ease extending *varadmudra* with right hand. Mallar Ghosh has declared that the cult of the Buddhist goddess *Tara* originated at Nalanda in the 5<sup>th</sup> Century A.D. (**Mishra, 1998: 39-68**)

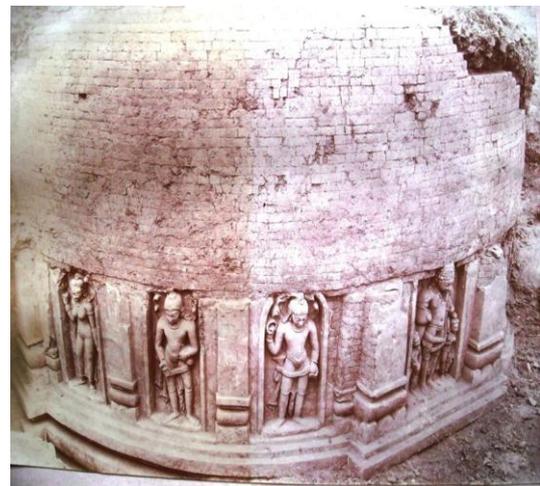
Figure13. General view of the stucco panel from Maniyar Math, Rajgir, Bihar

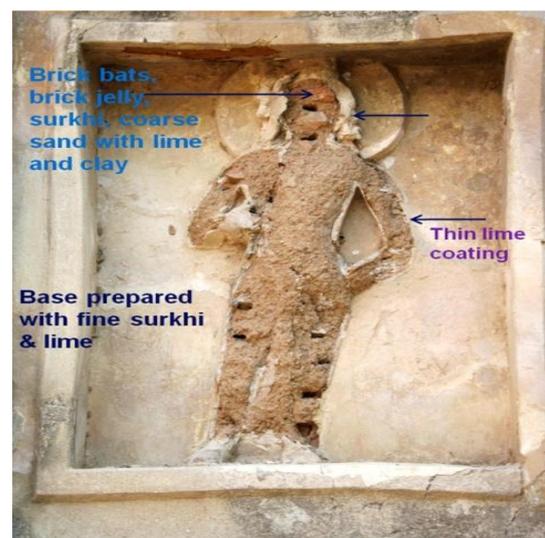
Figure14. An example of problem on Stucco image, Nalanda archaeological site, Nalanda, Bihar (Left)

Deterioration (Fig.14) to Stucco art is mainly caused due to natural weathering like water, wind, and direct sunlight, insect, vegetation growth and animals. Detail describe below:

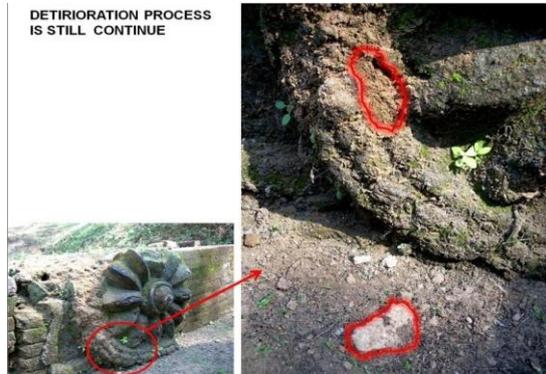
**Figure15.** On site example of stucco flaking, Nalanda archaeological site, Nalanda, Bihar (Right)

- After a long time due water and humid condition the lime plaster, brick layer and clay layer chip out; layer after layer and in this process cracks in every layer occurs and take out the painting. Parts of stucco have fallen down (Fig.15) on account of continued splitting, flaking, and spilling, weathering and physico-chemical disintegration of the rock. For this type of problems till now we do not have any solution

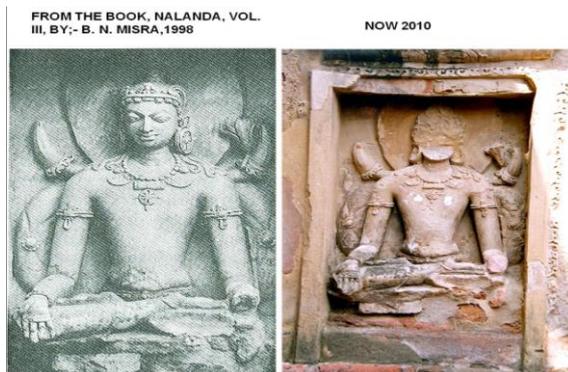
**Figure16.** Water seepage problem, Nalanda archaeological site, Nalanda, Bihar

In depth studies of the observations and practical experiences of other scholars have confirmed that water and water associated factors are directly or indirectly behind all the physical and biological damages that take place in these structures. Relative atmospheric humidity, and in the form of air humidity, water affects stuccos both mechanically and chemically. Flow of water (Fig.16) affects not only the outer face of stuccos but even inner core of the stucco and core medium in which the stuccos are stable. The stucco art deteriorated in three ways: (i) By washing off thin layer of mural, (ii) By depositing salts, clays and mineral components on the surface on it, (iii) By creating conditions suitable for cryptogammic growth.

From Conservation point of view maintenance should be done to the natural conditions and original environment of the stuccos. Conservation practices should keep sites as dry as possible should be adopted. Periodic checks should be made so that the water does not come on the stucco art and architecture where it is slowly directed towards the art work through porous rock and through cracks and fissures on the roof or floor. Water should be directed off the roof by natural looks pipe, and by allowing the water to runoff, by opening drainage lines to the side of the stucco work. In addition some minor drainage channels should be made above the stucco niches and locality. In this way runoff water can be diverted away from the stucco sculptures and other art.

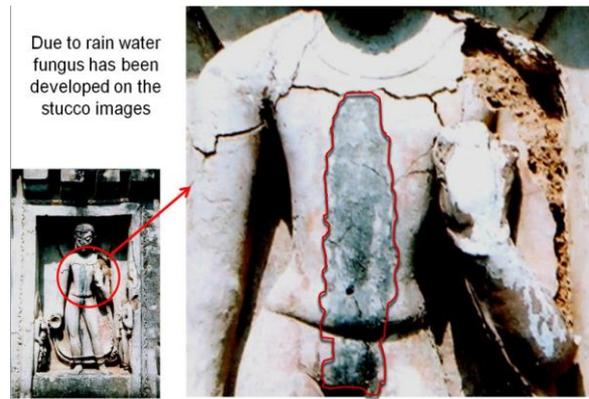
**Figure17.** The past and present of the same image, Nalanda archaeological site, Nalanda, Bihar

The most insidious destroyer of all is considered to be ground-water seepage and water percolation from top (Fig.17). The water movement carries salts such as calcium carbonate, calcium sulphate, sodium chloride and manganese oxide etc., all severely detrimental to these invaluable stuccos.

Archaeological chemist, conservation (Fig.17) has been done during 1919-20 to 2000 stucco specimens (IAR, 1954-55:38) Nalanda consist of chlorides and sulphate of alkalies and in the proximity of the sea, they are the sea salts deposited by the sea wind. In the rainy season they form a solution with water and penetrate the walls to certain height by capillary action, and crystallize at the exposed parts in dry weather, causing disintegration thereby. The cycle is repeated over and over again with changes of weather. That is why it's causing danger for this class of art.
